June 25, 2018

SUBJECT: Report of Level 1 Replacement Reserve Study  
North Shore at Canton Condominium  
2300 Block of Boston Street  
Baltimore, Maryland  
ETC Project M6-3011

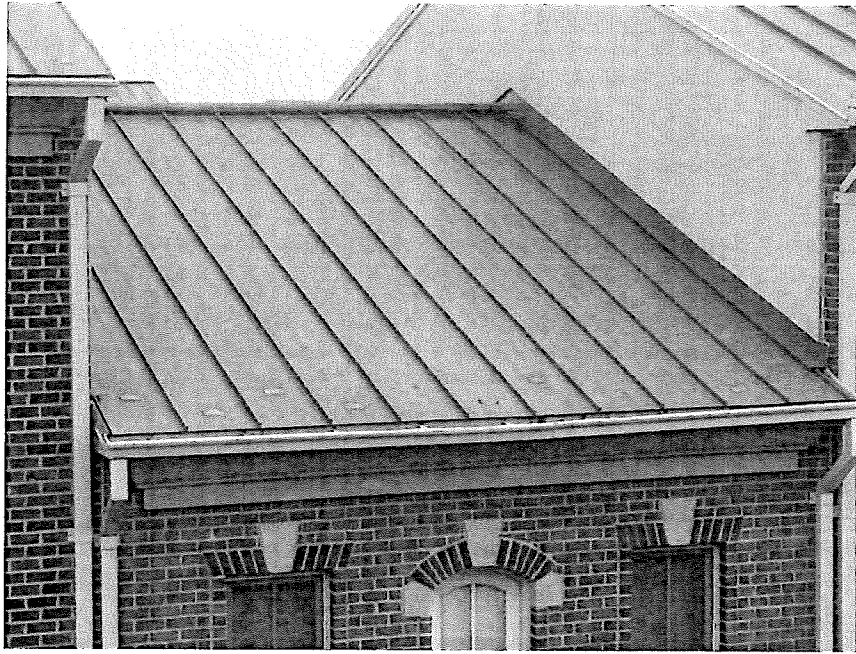
Photograph 1 - Missing snow guards on metal roof

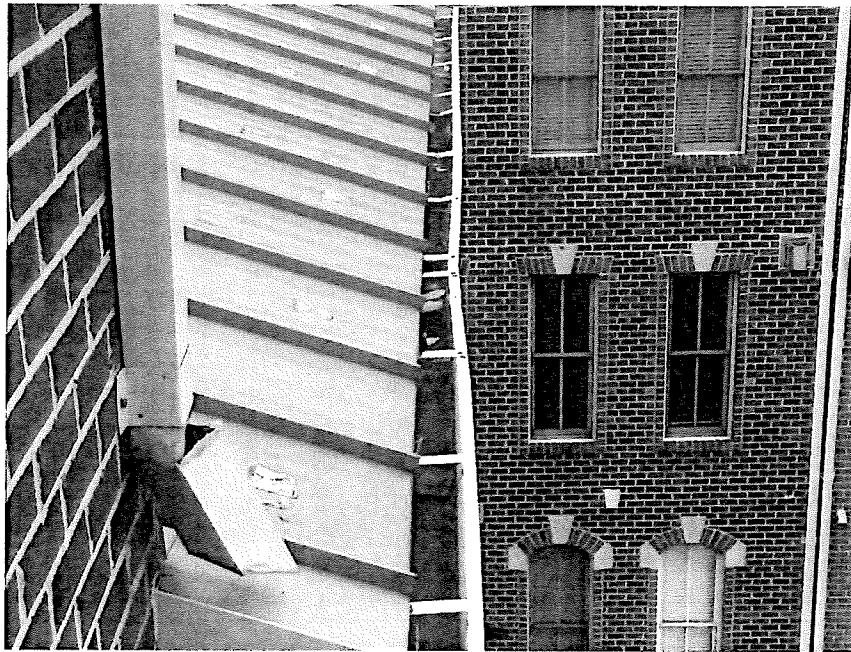
Photograph 2 - Dislodged section of downspout

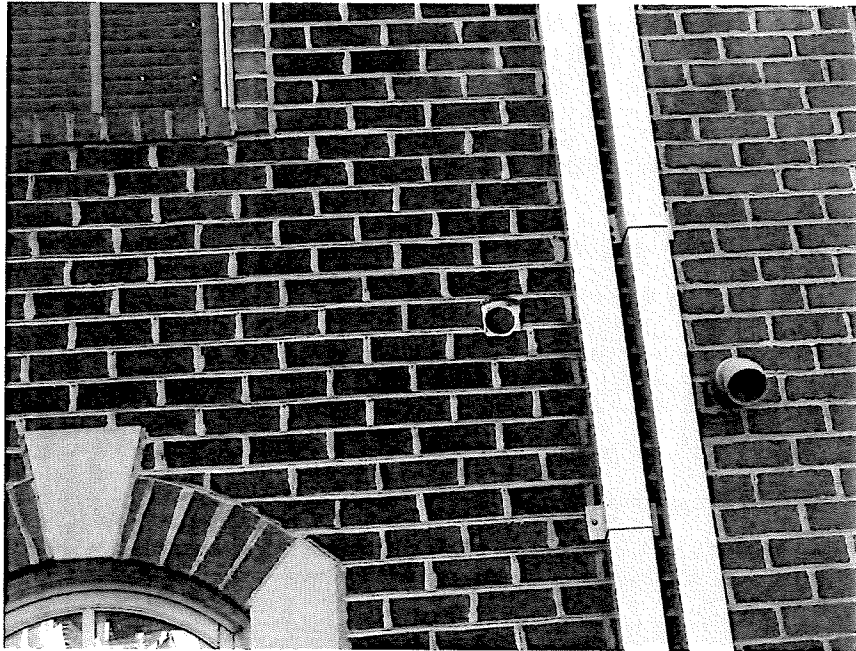
1. Some isolated mortar defects (cracks, bond breaks, etc.) were evident in the masonry (see Photograph 4).
2. What appeared to be a dryer vent was missing at 2319-3 Boston Street (see Photograph 5).
3. Ivy growth was noted on the several building end walls (see Photograph 6). Such plant growth can dislodge mortar joints as well as masonry units in some extreme cases. Additionally, plant growth tends to trap moisture against walls, which can lead to efflorescence or staining of the wall. Both of these conditions can reduce the life expectancy of brick masonry walls.

Photograph 5 – Missing dryer vent at 2319-3 Boston Street

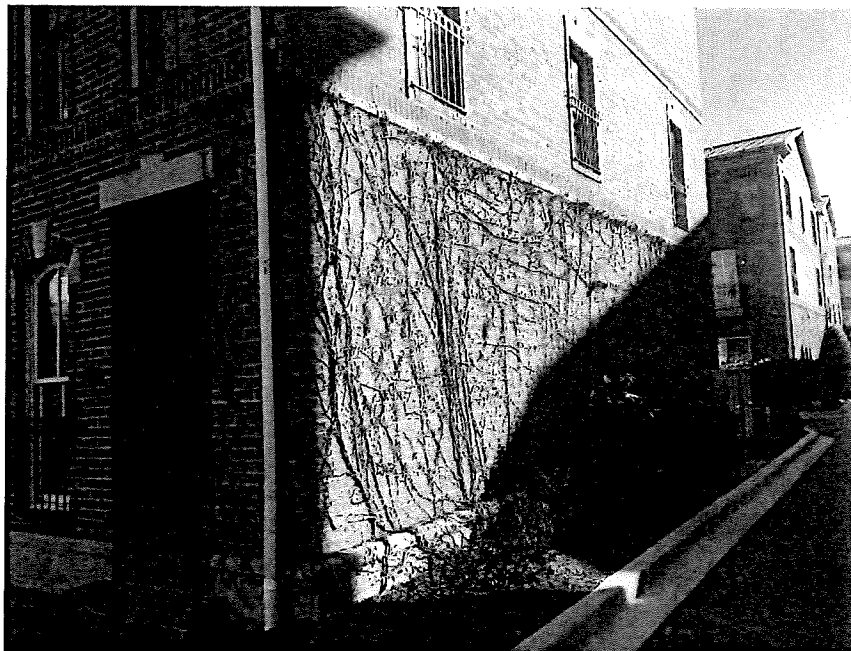
Photograph 6 – Ivy growth on brick masonry

2. Growths - Ivy, algae or other growths penetrate into the masonry, causing damage and allowing water penetration into the wall system. All such growths should be regularly removed and any damage found should be immediately repaired.

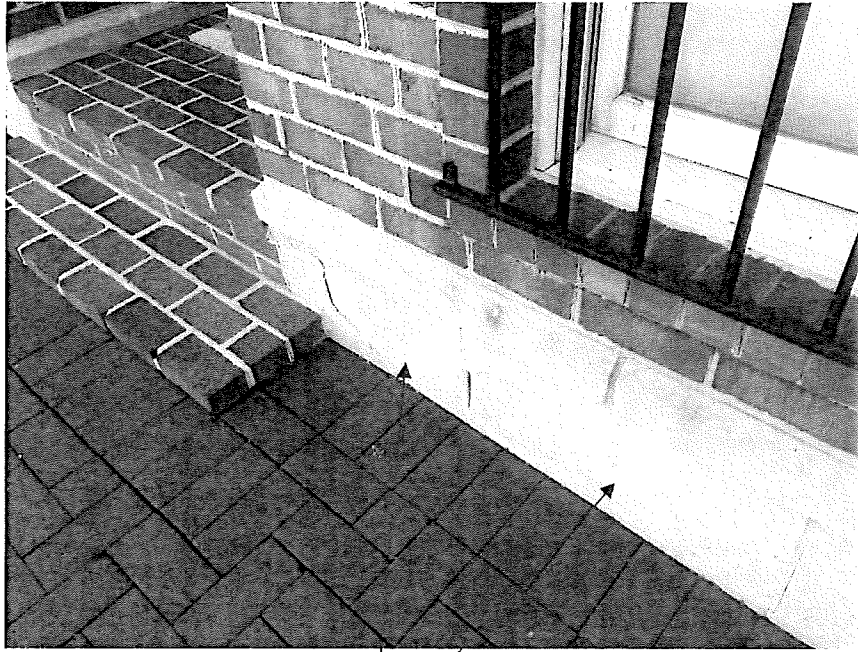
2. A few cracked units were noted in the stone masonry (see Photograph 7).
3. The faces of the precast stone units at ground level were severely deteriorated throughout the community (see Photograph 9). This condition was typically noted adjacent to sidewalks and is most likely caused by the deicing salts utilized on the sidewalks.

Photograph 9 – Deteriorated precast stone masonry units at ground level

Painting of the cellular PVC where debonded paint was noted could be delayed until a full painting project is undertaken. As for the deteriorated precast stone units along the sidewalks, they should be monitored for worsening conditions. Additionally, the Community should utilize a deicing agent on the sidewalks that is less destructive to concrete and masonry elements. Provided in Appendix D are some guidelines for maintaining and cleaning masonry.

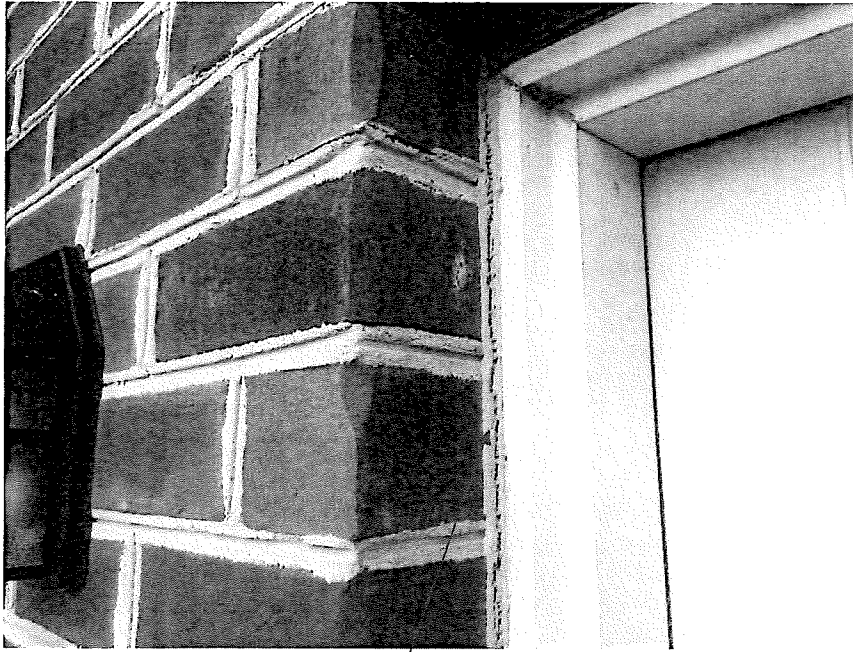
Photograph 13 – Deteriorated sealant at perimeter of door

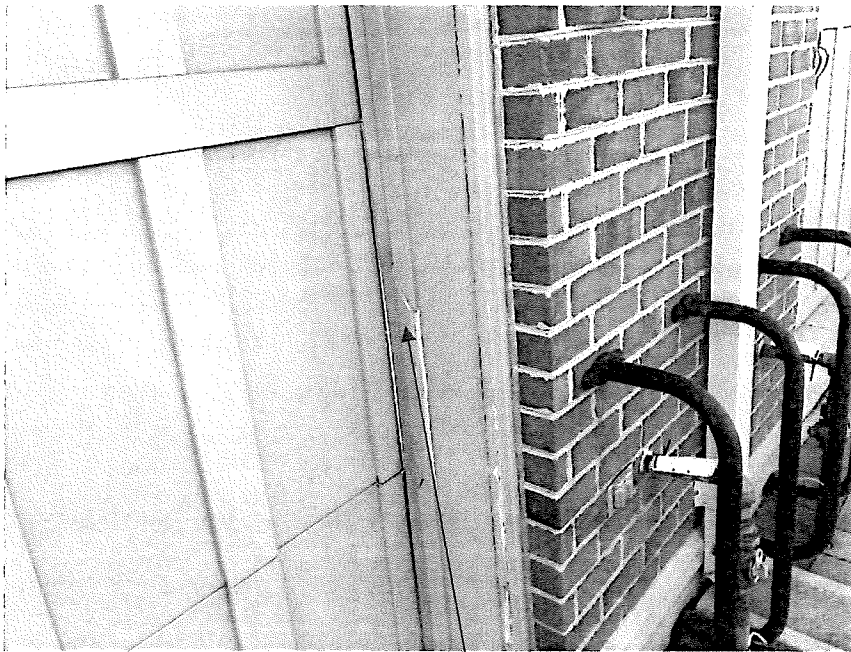
Photograph 14 – Broken trim at garage at 2323-5 Boston Street

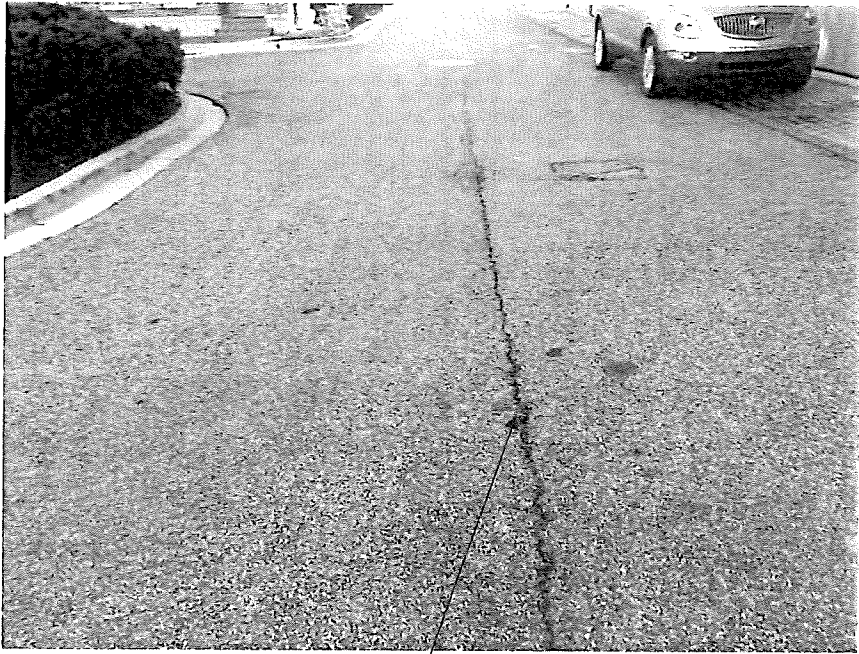
Photograph 17 – Simple crack in asphalt pavement

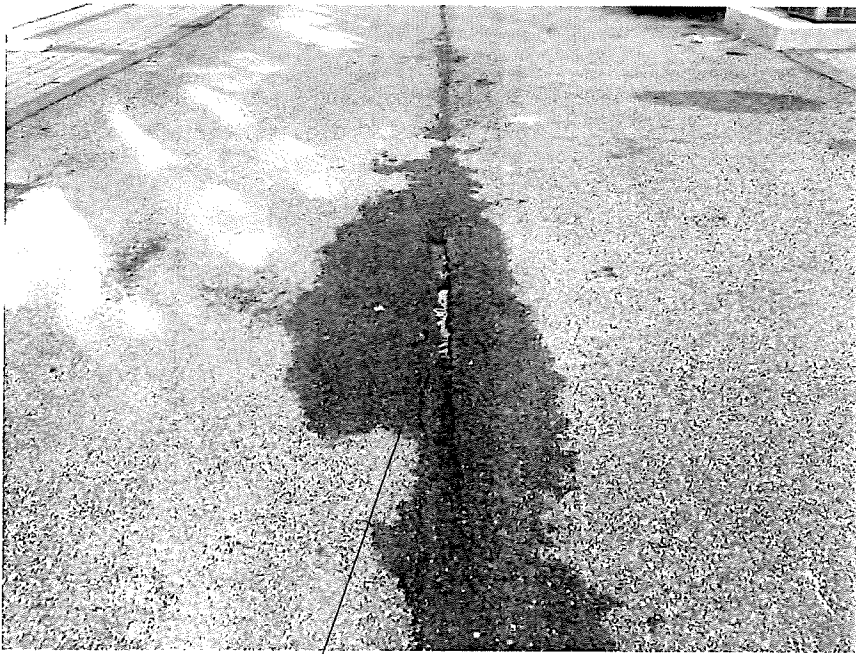
Photograph 18 – Deteriorated pavement along simple crack in asphalt pavement

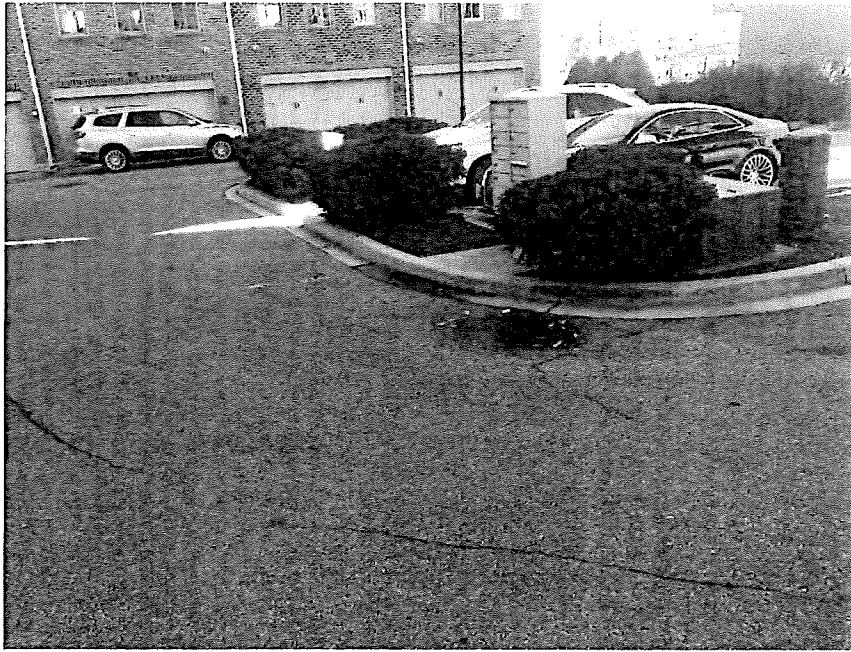
Photograph 21 – Area of ponded water in asphalt pavement

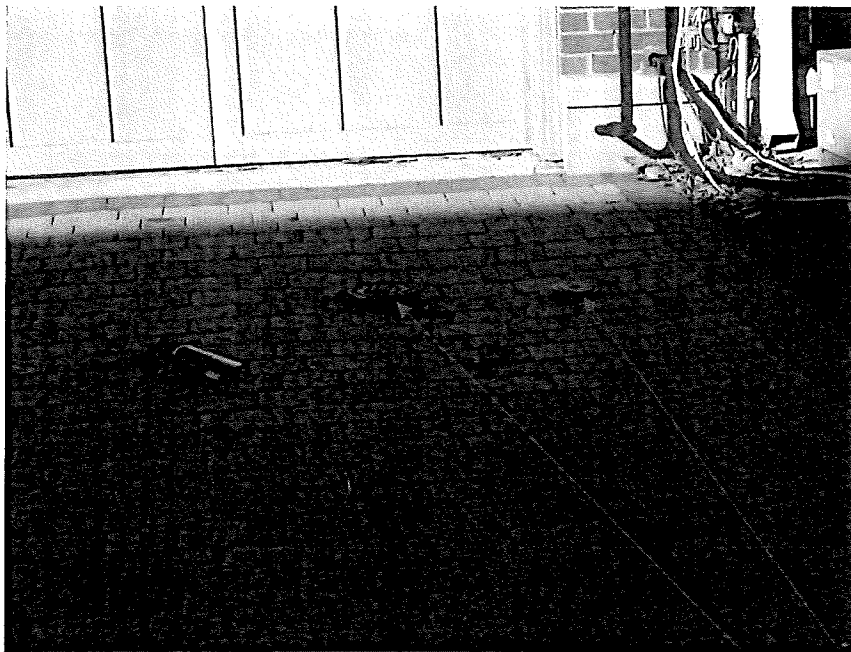
Photograph 22 – Sunken area of brick pavers in driveway apron – note utility covers elevated above level of brick pavers

The brick paver elements should be inspected annually for displacement and evidence of substrate erosion (voids). Seriously distressed areas should be mapped and clearly marked (for repairs). Correction of the most obvious (and potentially hazardous) conditions should be deemed imperative. Settlement, or other defects that result in a height disparity of one-half (1/2) inch or more present potential tripping hazards. These conditions indicate serious damage, which should be repaired properly.

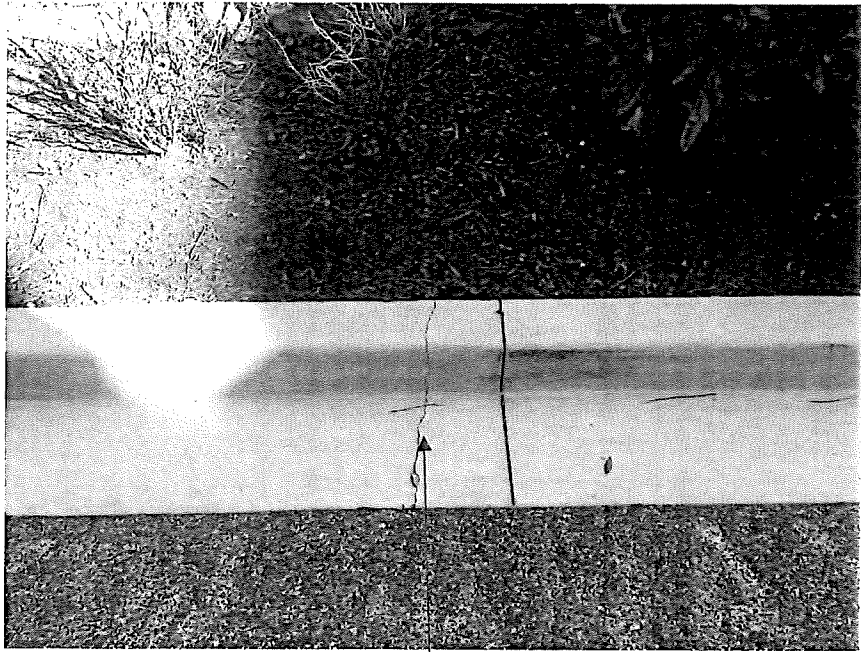
The concrete curb and gutter assemblies were in good condition as well. Minor cracks and scaling were observed in a few areas (see Photographs 25 and 26).

Photograph 25 – Crack in concrete curb and gutter assembly

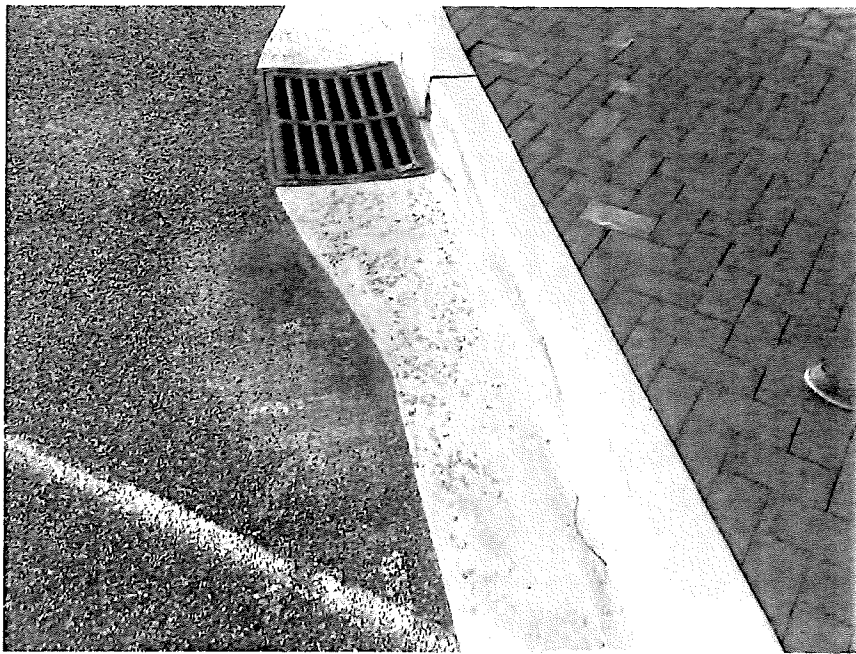
Photograph 26 – Scaled section of concrete curb and gutter assembly

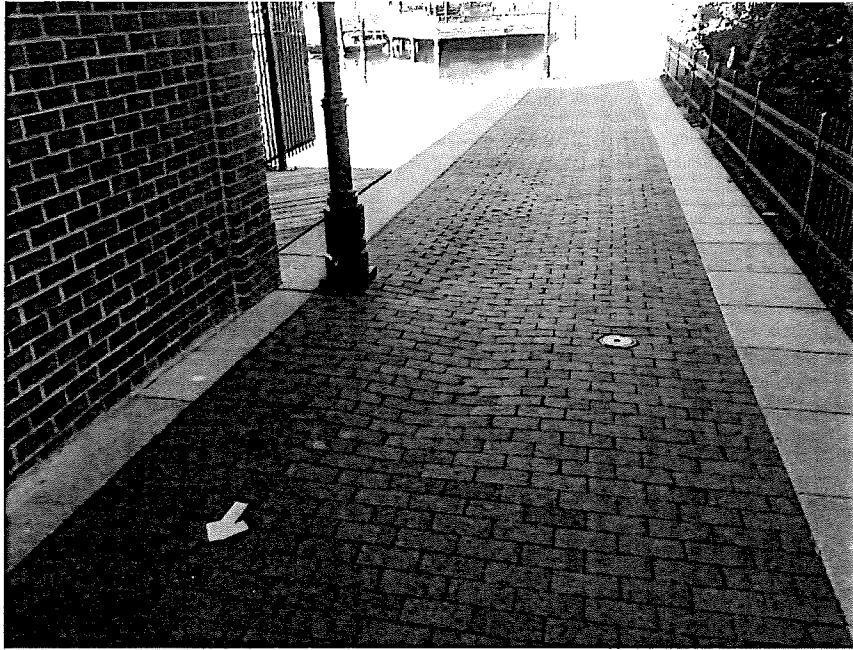
The promenade was generally in good condition during our inspection; although a few deficiencies or items of concern were noted during our inspection. Sunken/heaved areas of brick pavers were evident in a few locations along the promenade (see Photographs 28 and 29). This condition created an uneven surface, which could present a potential trip hazard. Additionally, this condition indicates a possible issue with erosion of the soils below the pavers. This is of more concern in this area due to the high traffic from runners and walkers outside the community. We were informed that the community had to undertake a major repair at the north end of the promenade previously where a large area of brick pavers had sunken. One of the sunken areas observed during our inspection was located in the area of the previous repair. Cracks and deterioration (spalls) in the concrete bands were observed in some areas (see Photographs 30 and 31).

Photograph 29 – Sunken area of brick pavers in promenade at the north corner of the property

Due to the high activity of others outside of the community, we recommend that sunken/heaved sections brick pavers in the promenade be repaired as soon as possible. The repairs should include removal of the brick pavers and the underlying materials to assist in determining the source of the erosion underneath the pavers. The cracks in the concrete elements should be routed and sealed. Any delaminated areas in the concrete elements should be properly repaired.

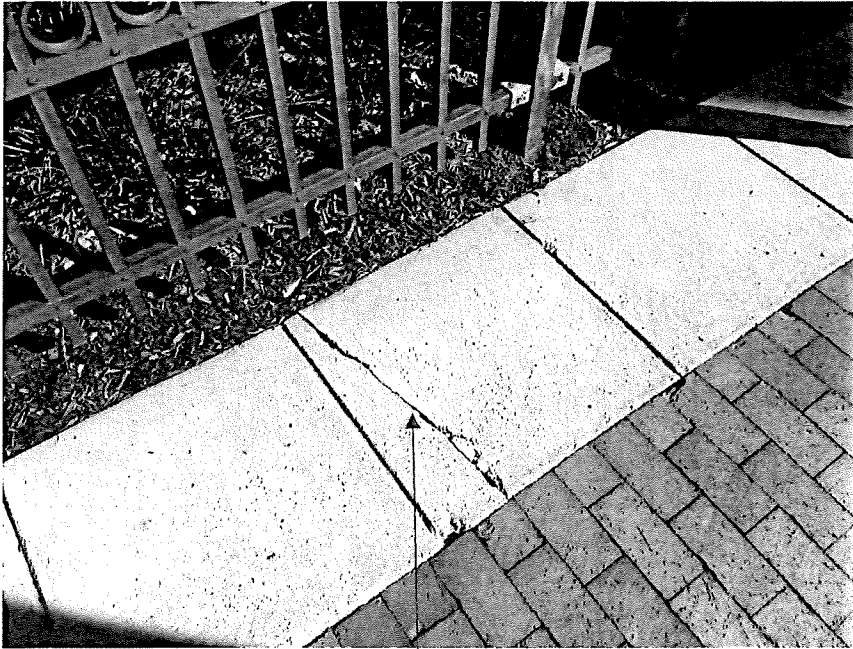
Photograph 30 – Crack in promenade concrete boarder

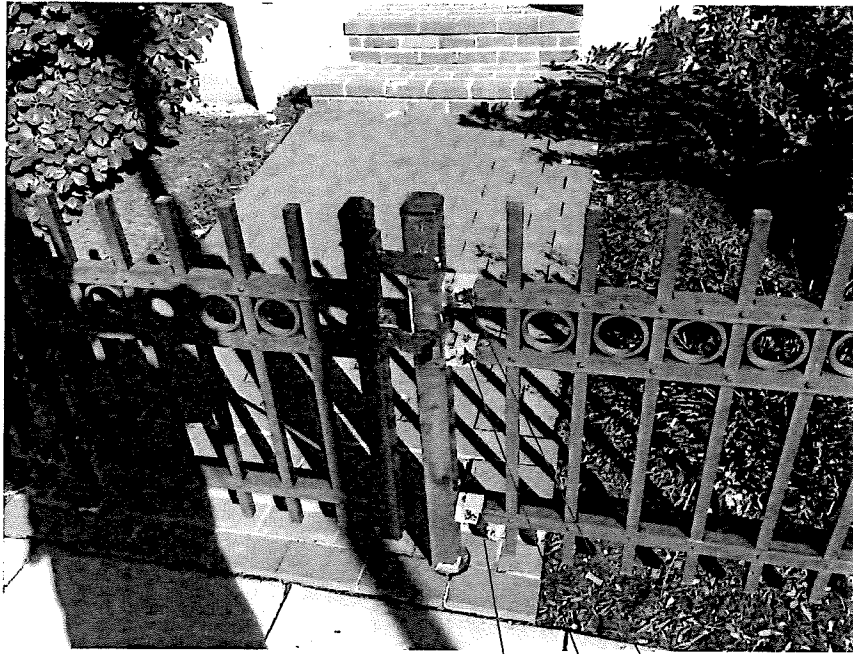
Photograph 33 – Debonded paint on fencing attachment components

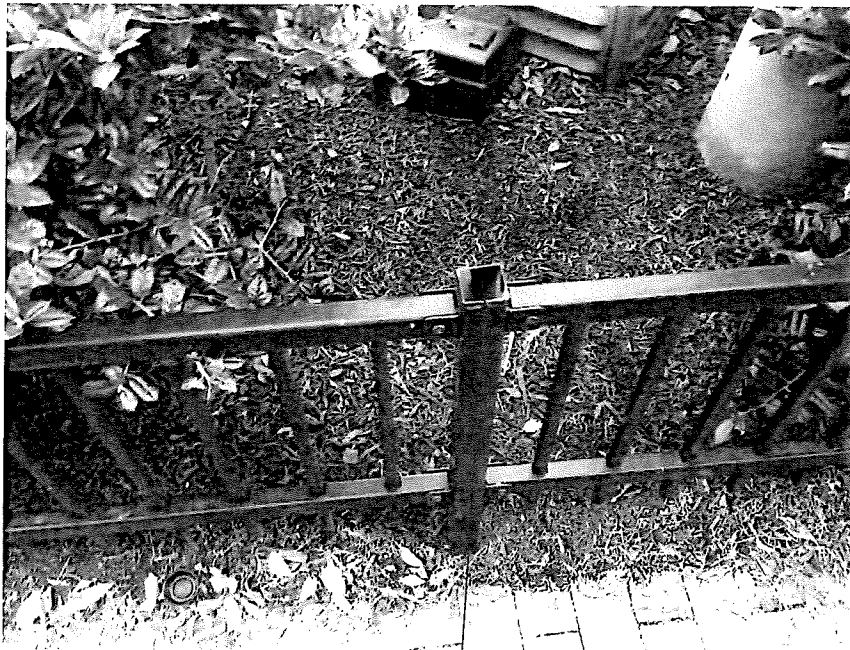
Photograph 34 – Missing fencing post cap

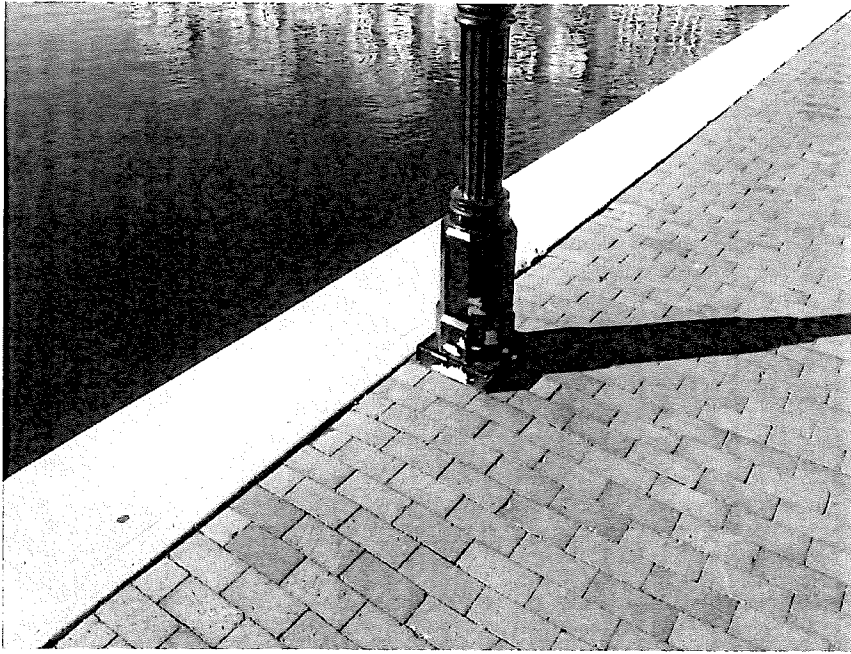
Photograph 37 – Debonded paint on promenade light post
