THE HOUSE IN PERSPECTIVE – General observation of the home in its current condition.

Overall, the 1982 home, which has multiple additions, is in a satisfactory or typical condition for the age with various repairs needed or advised at this time. See below and through the report for all the details. The exterior lighting, generator, and pool were not a part of the inspection. Please call with any questions.

Location	Inspector
4037 Holly Knoll Drive Glen Arm MD 21057	Jonathan Blevins Environmental Inspector

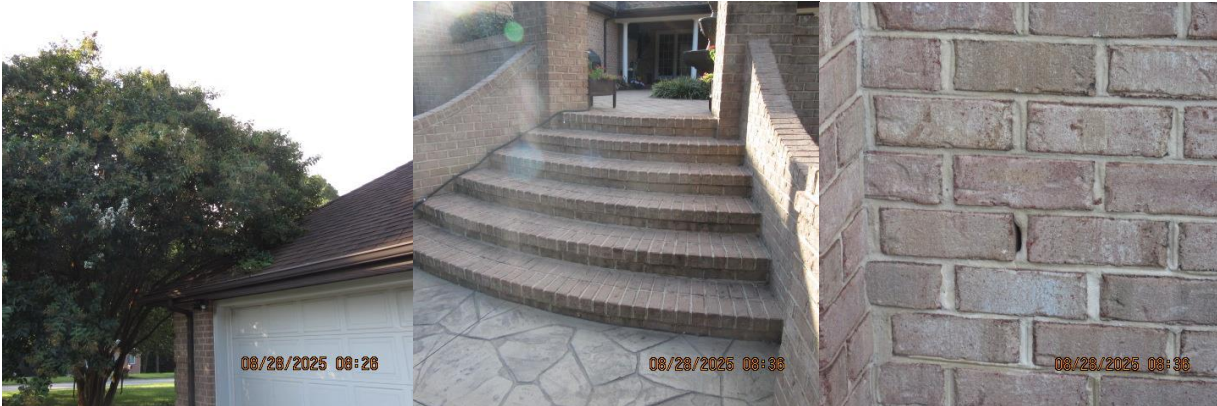
YARD STEP

Repair, Safety Issue: Ideally there should be a handrail installed at the rear yard steps.

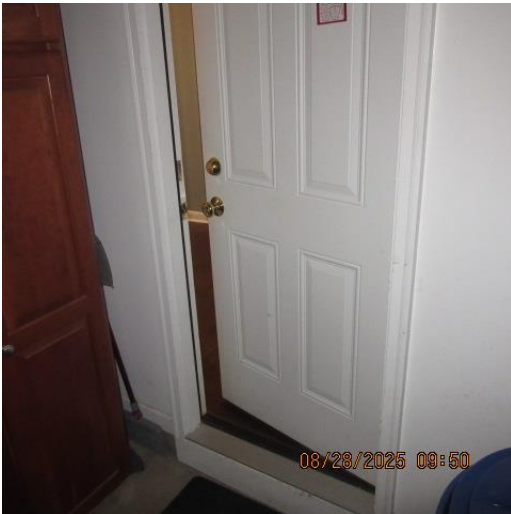
GARAGE

Improve, Safety Issue: The door between the attached garage and the interior of the house should ideally be fire rated, self closer with at least a 4 inch threshold. The current door does not meet this standard; advise upgrading.

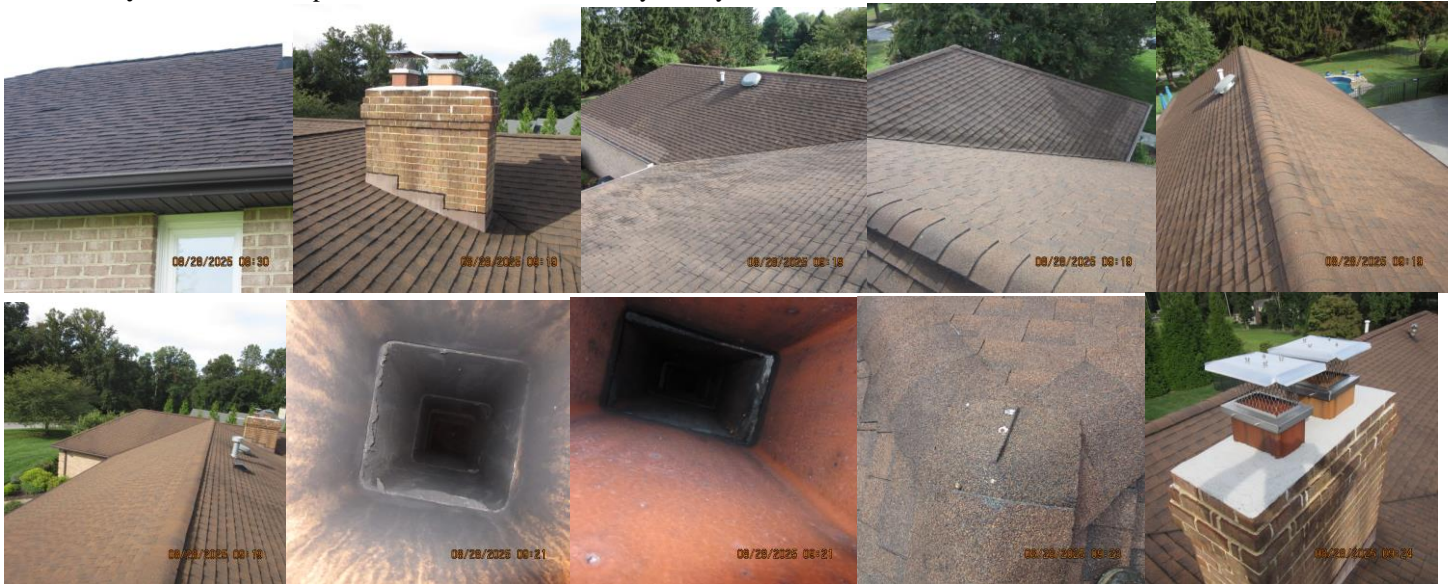
CHIMNEY/FLUES

Satisfactory: No obvious repairs were seen for the chimneys today.

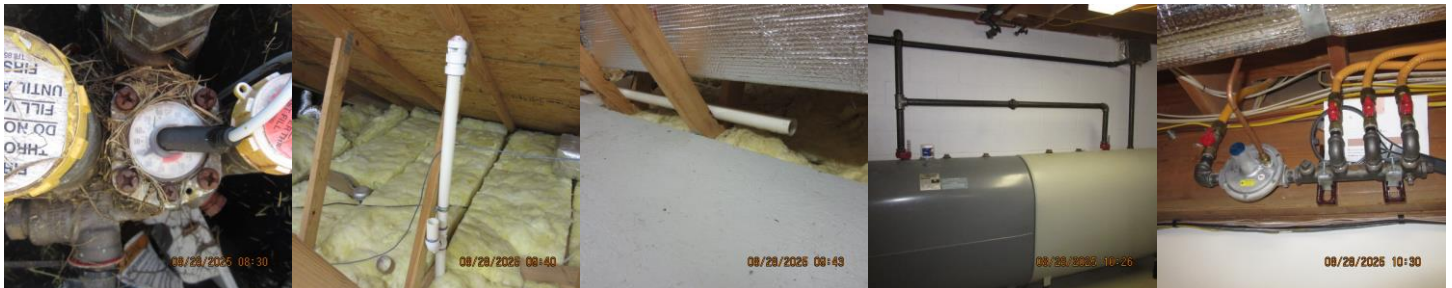
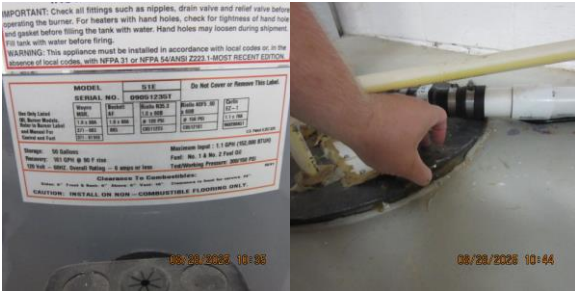
Service: The water conditioning equipment in the basement should be serviced. The salt for the water softener did not look like it had been filled in some time.

Improve: The water pressure in the bathrooms was somewhat lower when multiple bathroom fixtures in multiple bathrooms were being run at once. Changing the well pressure switch to a 40/60 switch may help alleviate this. The well pressure switch appears to currently be 30/50 PSI.

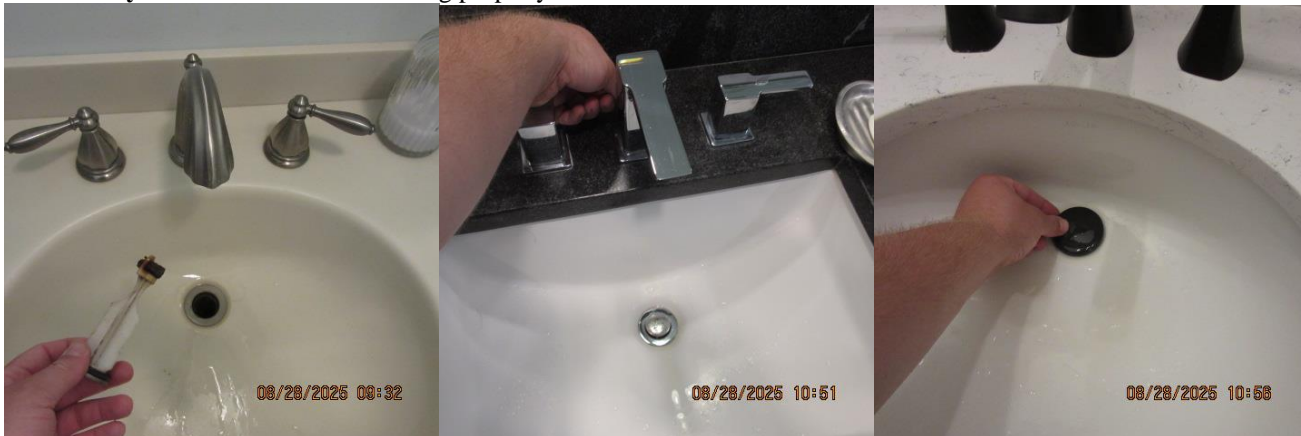
INSPECTION FOR THE GARAGE POWDER ROOM

Satisfactory: The toilet is working properly.
Repair as desired: The sink stopper in the garage bathroom is damaged. Repair or replace as desired.
Satisfactory: The exhaust fan is working properly.

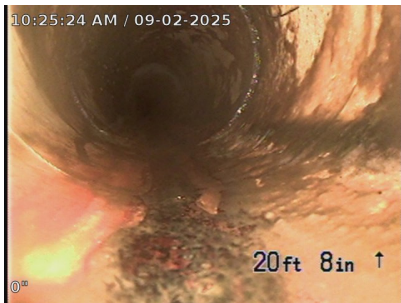
Connection to what may be a snake line; however, this could not be located at grade. There is a patio over the front line.

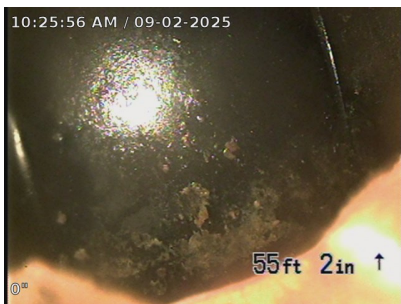
End of front line inside septic tank. The front line was found to be clear of obstructions and breaks.

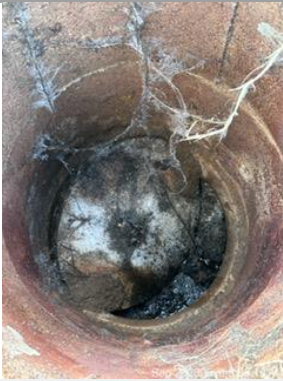
Picture 2:

Showing the inside of the first chamber. The handle on the tank lid is broken, making removing the lid more difficult.

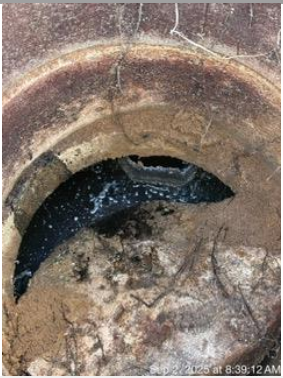
Picture 3:

Showing the inside of the second chamber and the plastic back baffle.
